Hyundai Santa Fe
Standard Safety Equipment

2018

Tested Model	Hyundai Santa Fe 2.2CRDi, LHD
Body Type	- 5 door SUV
Year Of Publication	2018
Kerb Weight	1950kg
VIN From Which Rating Applies	- all Santa Fe
Class	Large SUV

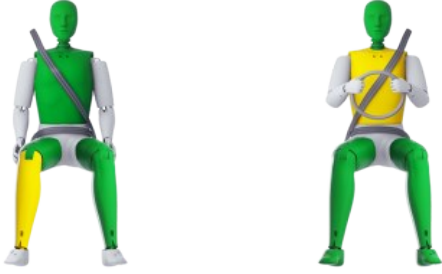
Frontal Offset Deformable Barrier 7.9 / 8 Pts

Passenger Driver

The passenger compartment remained stable in the frontal offset test. Dummy readings indicated good protection of the knees and femurs of both the driver and passenger dummies. Hyundai showed that a similar level of protection would be provided to occupants of different sizes and to those sitting in different positions. In the full-width rigid barrier test, protection of all critical body areas was good for the driver and good or adequate for the rear passenger. In the side barrier test, dummy readings indicated good protection of the driver. However, the side curtain airbag got caught on the trim of the C-pillar and did not deploy as intended. Moreover, the airbag was seen to have torn during deployment. Hyundai investigated the tear and have changed the airbag attachment fixings of affected vehicles in production and have issued a recall for all vehicles with a panoramic roof. Owners are encouraged to take their vehicles to dealers when asked to do so. The side barrier test was repeated with changed airbag attachment fixings and no tearing was seen. However, the airbag still did not deploy as intended and protection of the driver's head, in the side barrier and side pole tests, was downgraded to adequate. Tests on the front seats and head restraints demonstrated good protection against whiplash injuries in the event of a rear-end collision. However, a geometric assessment of the rear seats indicated poor whiplash protection. The standard-fit autonomous emergency braking (AEB) system performed well in tests of its functionality at the low speeds, typical of city driving, at which many whiplash injuries are caused.

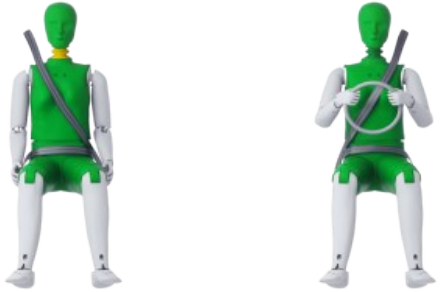
Frontal Full Width 7.8 / 8 Pts

Rear Passenger Driver

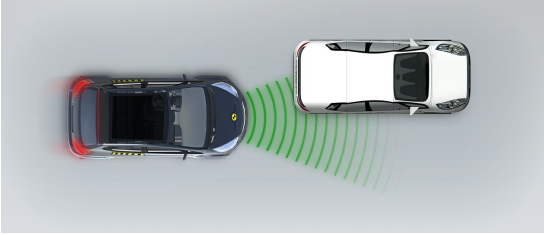
Approaching a stationary car: Left Offset

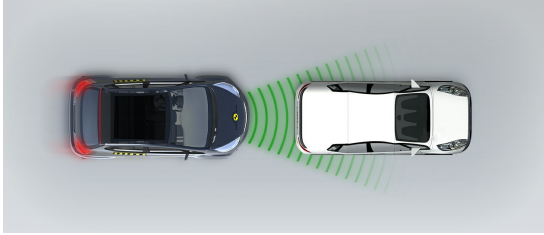
Approaching a stationary car: No Offset

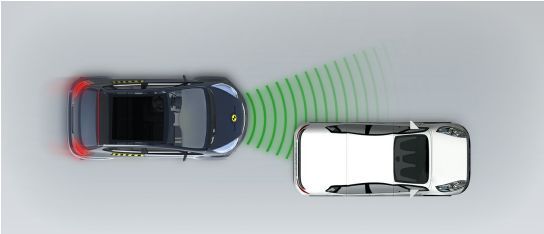
Approaching a stationary car: Right Offset

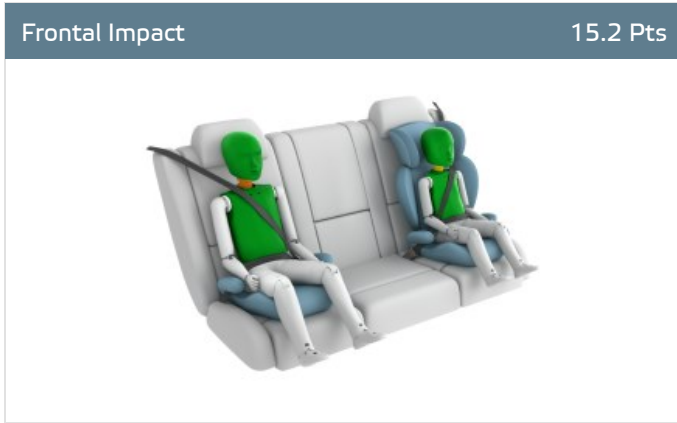
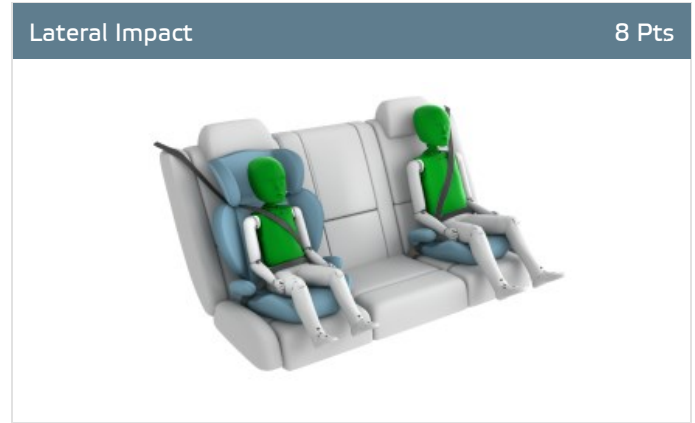
Crash Test Performance based on 6 & 10 year old children

23.2 / 24 Pts

Restraint for 6 year old child: *Britax Römer KidfixXP II SICT*
 Restraint for 10 year old child: *Booster Cushion*

In the frontal offset test, protection of all critical body areas was good or adequate, except the neck of the 10 year dummy, protection of which was rated as marginal, based on dummy readings of neck tension. In the side barrier test, protection was good for all critical body areas. The front passenger airbag can be disabled to allow a rearward-facing child restraint to be used in that seating position. Clear information is provided to the driver regarding the status of the airbag and the system was rewarded. All of the restraint types for which the Santa Fe is designed could be properly installed and accommodated in the car.
