TEST RESULTS

Daihatsu Sirion

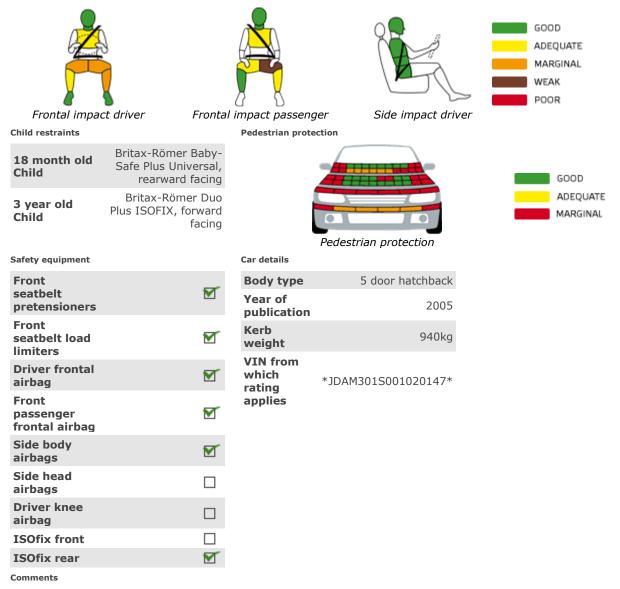
Adult occupant protection

Front impact

The passenger dummy's left knee registered higher loads than the driver's and was used in the adult occupant score. Structures in the knee-impact areas represented potential hazards to the knee and femur protection for both driver and passenger.
