CUPRA Formentor  
Standard Safety Equipment

2025

| Tested Model | CUPRA Formentor 1.5 eTSI 4x2, LHD |

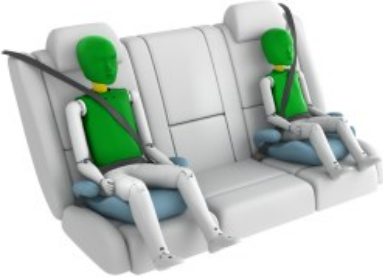
Frontal Impact15.6 Pts

In the frontal offset test, protection of all critical parts of the body was good or adequate for both the 6 and 10 year dummies. In the side barrier impact, protection of all critical parts of the body was good for both. The front passenger airbag can be disabled to allow a rearward-facing child restraint to be used in that seating position. Clear information is provided to the driver regarding the status of the airbag and the system was rewarded. The CUPRA Formentor is equipped with an indirect 'child presence detection' system, which issues a warning when it recognises that a child or infant may have been left in the car. Indirect systems are no longer rewarded by Euro NCAP. All of the child restraint types for which the CUPRA Formentor is designed could be properly installed and accommodated in the car.

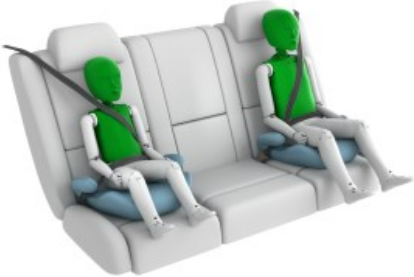
Lateral Impact8 Pts
