Volkswagen Multivan  
Standard Safety Equipment

2025

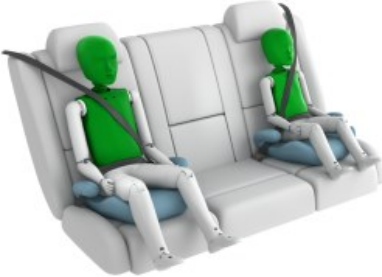
Frontal Impact16 Pts

Crash Test Performance based on 6 & 10 year old children 24.0 / 24 Pts

Restraint for 6 year old child: Volkswagen Original Kindersitz "Kidfix i-SIZE"  
Restraint for 10 year old child: Volkswagen Original Kindersitz "Kidfix i-SIZE"

In both the frontal offset and the side barrier tests, protection of all critical body areas was good for both the 6 and 10 year dummies, and the Volkswagen Multivan scored maximum points in this part of the assessment. The front passenger airbag can be disabled to allow a rearward-facing child restraint to be used in that seating position. Clear information is provided to the driver regarding the status of the airbag and the system was rewarded. The Volkswagen Multivan is equipped with an indirect 'child presence detection' system, which issues a warning when it recognises that a child or infant may have been left in the car. Indirect systems are no longer rewarded by Euro NCAP. All of the child restraints for which the Multivan is designed could be properly installed and accommodated. The rear centre seat can be moved to sit either in the second row or the third row. The car was tested with the seat in the third row but, for illustrative purposes, the diagram shows the seat in the second row. The score is unaffected by the position of the rear centre seat.
