Opel/Vauxhall Corsa

RATING	SCORE	Front: 7 Side: 11

Adult occupant protection

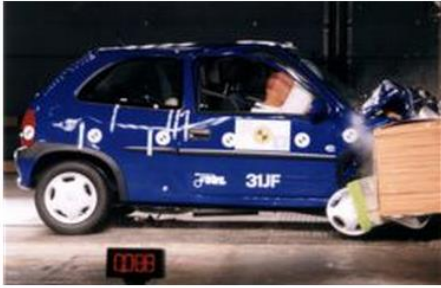
Frontal impact driver

Frontal impact passenger

Side impact driver

The driver's head rolled off the airbag and struck the facia. The buckle mounted pre-tensioners were found to be ineffective. The driver's footwell suffered a substantial seam rupture that shows instability. There were hard areas for the knees to hit which would cause high loads on the upper legs as well as provide localised loading, inducing penetrating injuries. A stiff bar at shin level could also cause injuries. There were no deflector plates or padding in the steering column shroud. The centre rear seat had only a two-point static belt, which could cause severe spinal and abdominal injuries.

The driver's ribs contacted the side wings of the seat and the door trim. There was protective padding for the abdomen but none for the chest. A stiff mounting peg halfway along the door could lead to a high load being placed on the driver's upper leg.
